**Problem:**

Inoperable cushion seals and damaged sealing bands on band-type cylinder

Actuator internal cushions vs. external shock absorbers: Knowing when and how to use them is crucial for maximum actuator life.

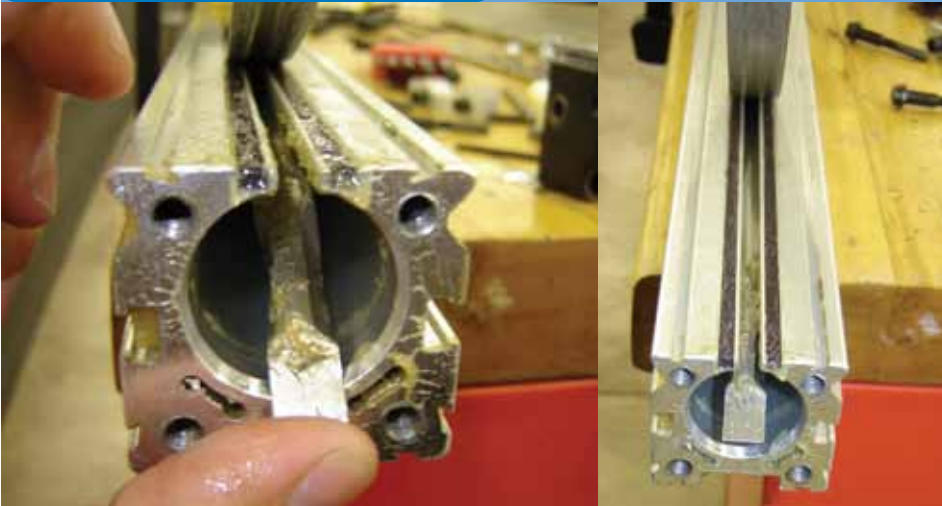
Inertia spikes and final velocity speeds exceeding actuator cushion capacities

Exceeding the capacity of the actuator's internal cushions can cause irreparable damage to the cushion seals and sealing bands.

Application of external shock absorbers

Once shocks were installed properly in this application, damage to the actuator was eliminated and the product performed flawlessly.

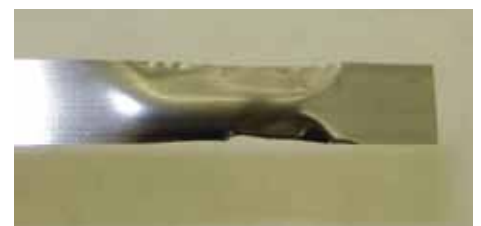
being analyzed had been running for two weeks when erratic behavior was noticeable. After inspecting the cylinder, it was determined that the actuator's internal cushions were rendered inoperable due to damaged seals. Removing the head from the actuator also revealed that the sealing band was bent and "cupped", a sign that an inertia spike was causing the damage.

The actuator's sealing band experienced cupping damage caused from inertia spikes.

In this installation, there were several factors that led to actuator failure. Although flow controls were being used, there were no initial adjustments made to the actuator's internal cushions at the time of installation. As a result, pressure built up at the end-of-stroke because the cushion needle was not allowing the pressure to exhaust. Pressure spikes resulted, causing damage to the seals and band. Once this occurs, the cushion becomes

inoperable and air leaks from the sealing band.
